## A Survey of Thatched Buildings in Scotland

Thatch Survey of Scotland  
2014-15

A photographic survey of thatched buildings in Scotland, surveyed between May 2014 and August 2015 by Zoe Herbert (SPAB Scotland Officer), on behalf of the Society for the Protection of Ancient Buildings.

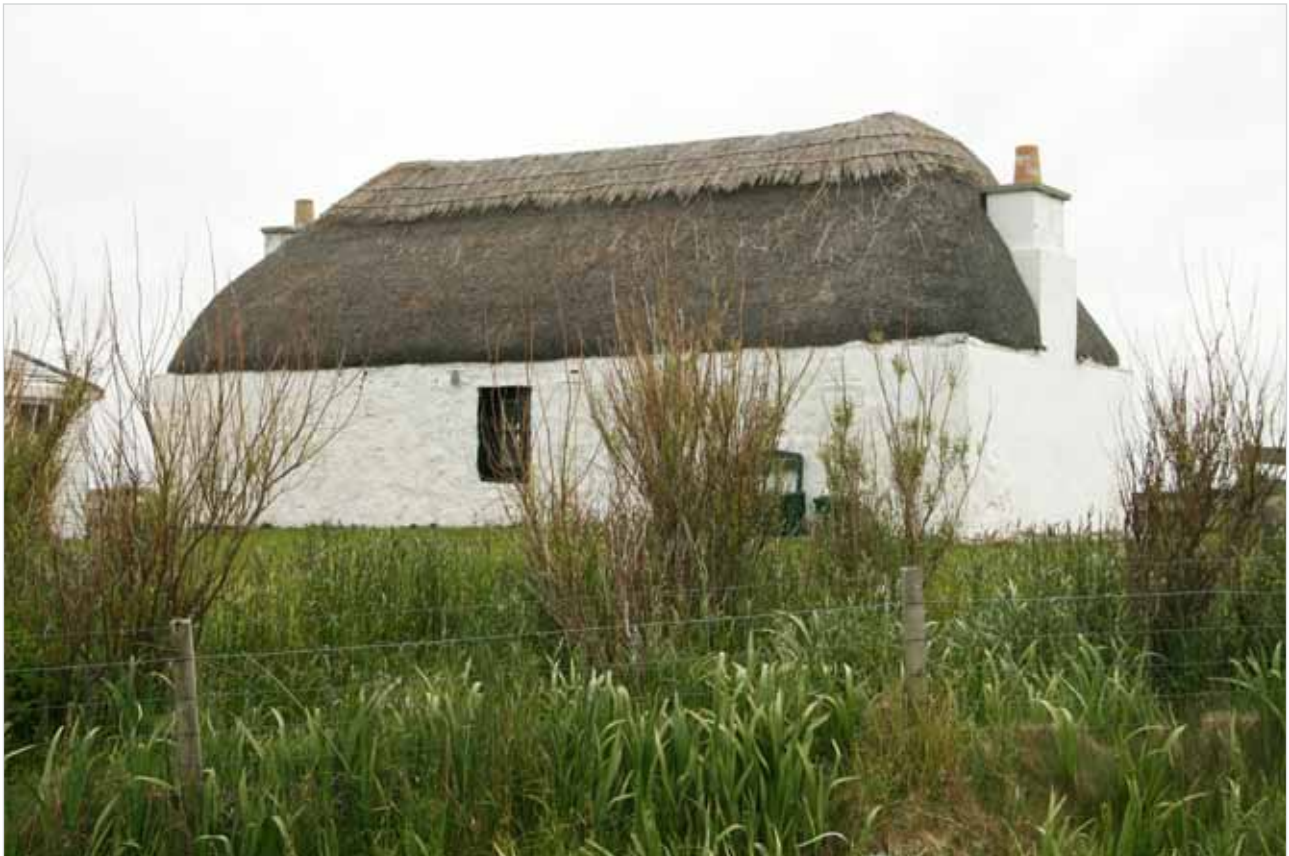
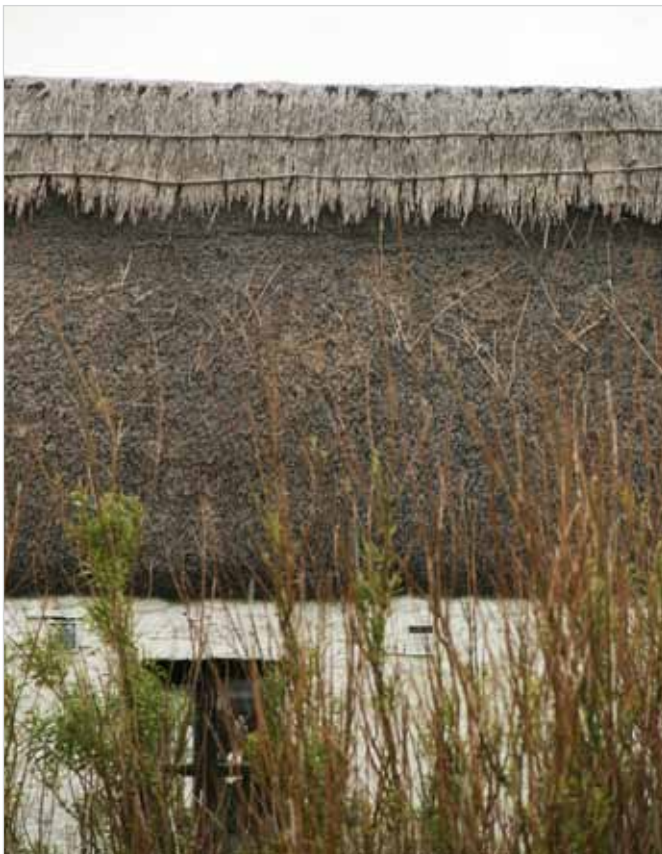
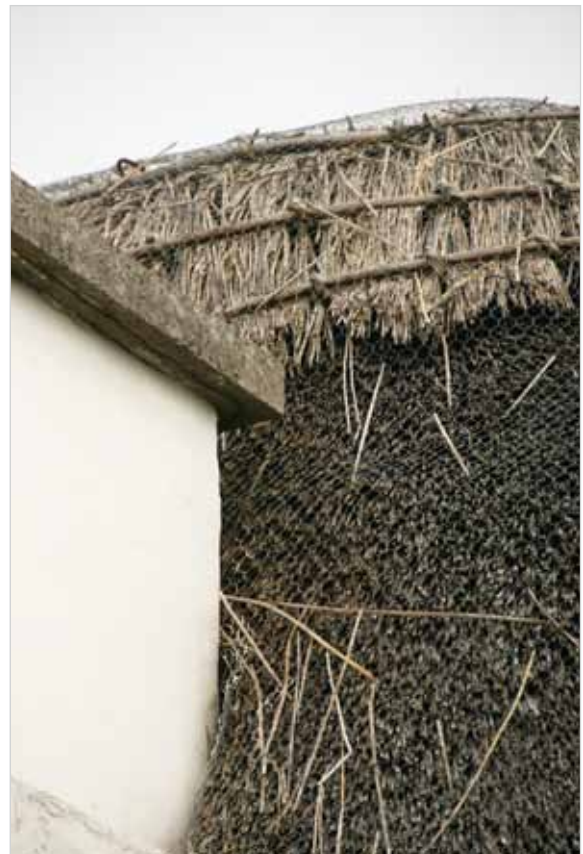
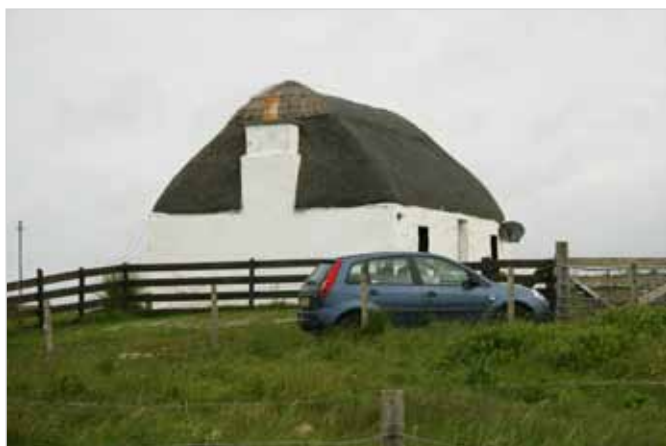
Taigh Violet Rose – Western Isles

Additional Notes: ..... Late 19th/early 20th-century cottage, listed as having a 'muran thatch roof secured with ropes and modern bricks as weights'. The roof is now thatched in reed and has what appears to be a straw ridge, which has been scobed with hazel spars. The roof has been entirely netted, including across the ridge. The thatch is in a good condition; however there are some pieces of dislodged thatch from the ridge that have fallen down the roof within the netting. The grid reference recorded for this building in the listing description and by Canmore is incorrect and identifies an empty piece of land in another part of the island (grid reference NF 80099 52242).

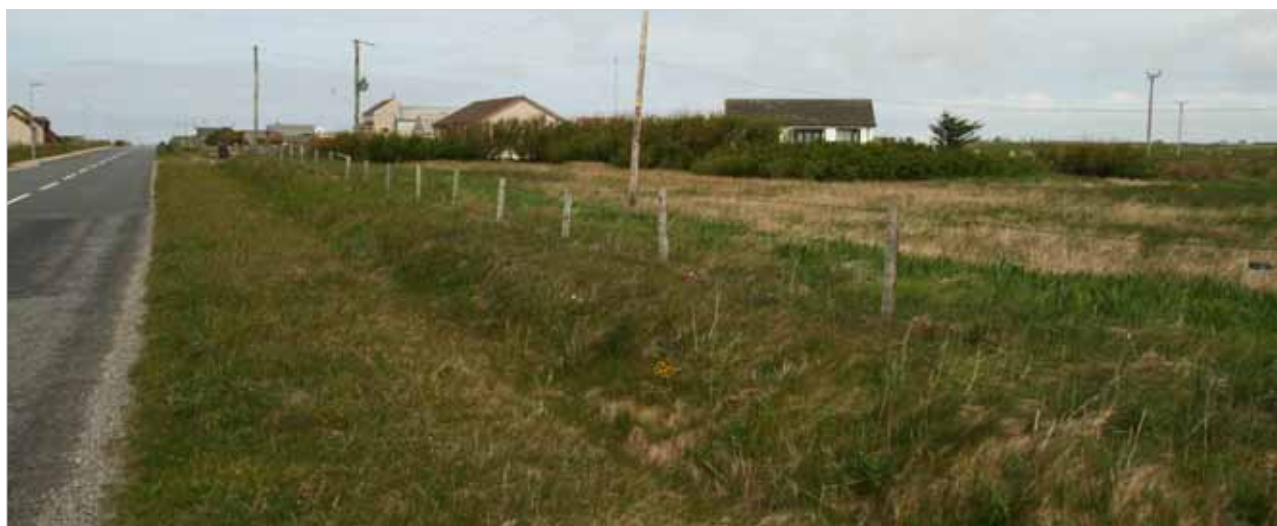
Address: ..... 9 Liniclate

**Additional Notes:** ..... The listed building description reads 'Late 19th/early 20th century. Skye-type thatched cottage. Single storey. Rubble-built with battered wall and curved angles. Long east front, with door off-centre north & diminutive window off-centre south; 2 west-facing windows, single window to short south wall. Single end stack; muran thatch roof secured with ropes and stone weights'. The grid reference identified by Historic Environment Scotland and Canmore shows an empty field, which has no visible signs of any building remains. It is unclear whether the location identified is incorrect or whether the building has been completely removed and the site grown over with grass, as there is no building or building remains nearby that matches the listed building description for this building. Further research is required and the listing description should be updated accordingly.

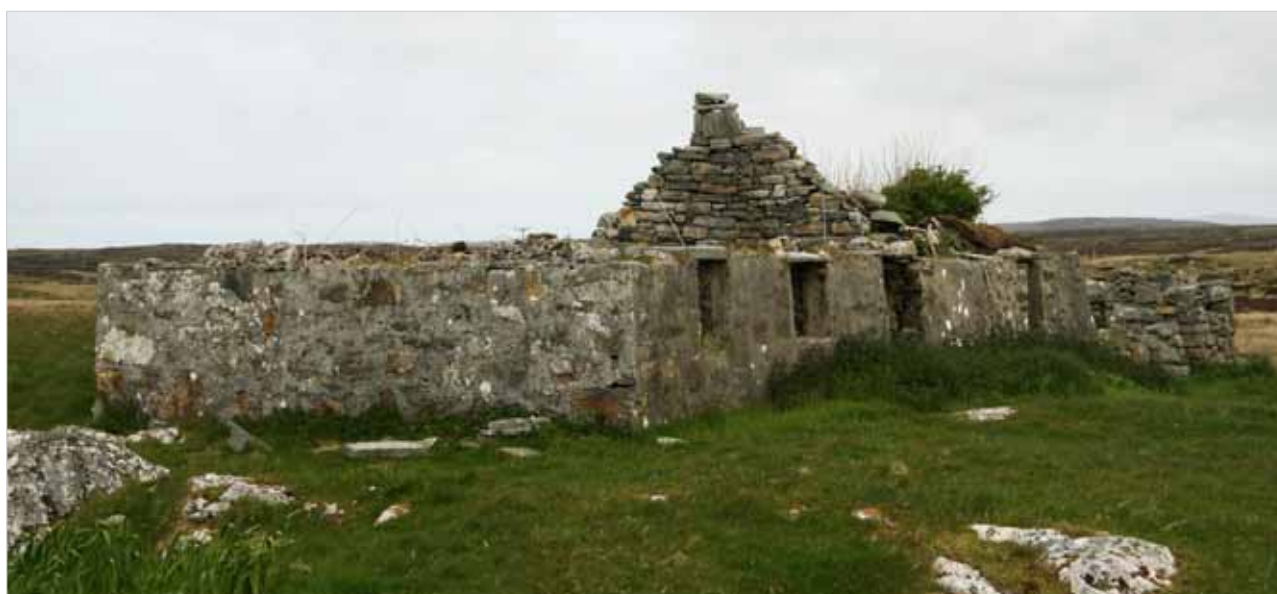
Address: .....5-6 Hacklet

**Additional Notes:** ..... Probably 19th-century cottage listed as having a '*muran* thatch roof secured with ropes and stone weights'. The building is now a roofless ruin and has been on the Buildings at Risk (BAR) Register since 1996 (BAR reference number 1784), at which time it was recorded as being '*abandoned and derelict with its roof caving in*'. BAR inspection in 2010 found the building to be a '*roofless shell in the slow process of collapse*'. There is visible evidence of what appears to be thatching material slumped over the wallhead on part of the north section of the cottage, as well as evidence of the ropes used for weighting. The listing description for this building should be updated accordingly. ....

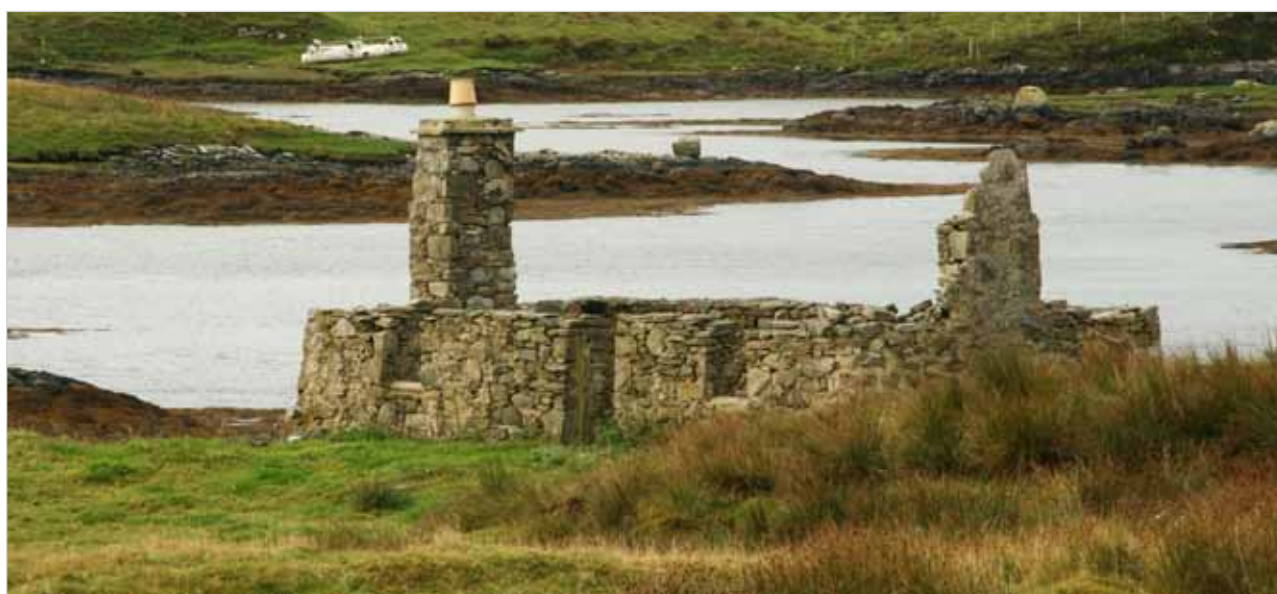
Address: ..... 4 Kilerivagh

**Additional Notes:** ..... The listed building description reads 'Late 19th/early 20th century, Skye-type thatched cottage' with 'muran thatch roof, secured with ropes and stone weights'. The building is now a roofless ruin and has been on the Buildings at Risk (BAR) Register since 1996 (BAR reference number 1917), at which time it was recorded that it was being used for hay storage, was in a decaying condition and that 'its grass-covered roof appear[ed] in danger of collapse'. In 2000 an application was submitted to convert the building into a holiday home, which was granted permission in 2001. In 2002, BAR recorded that the cottage had been damaged by fire and the roof had now gone. The listing description for this building should be updated accordingly.

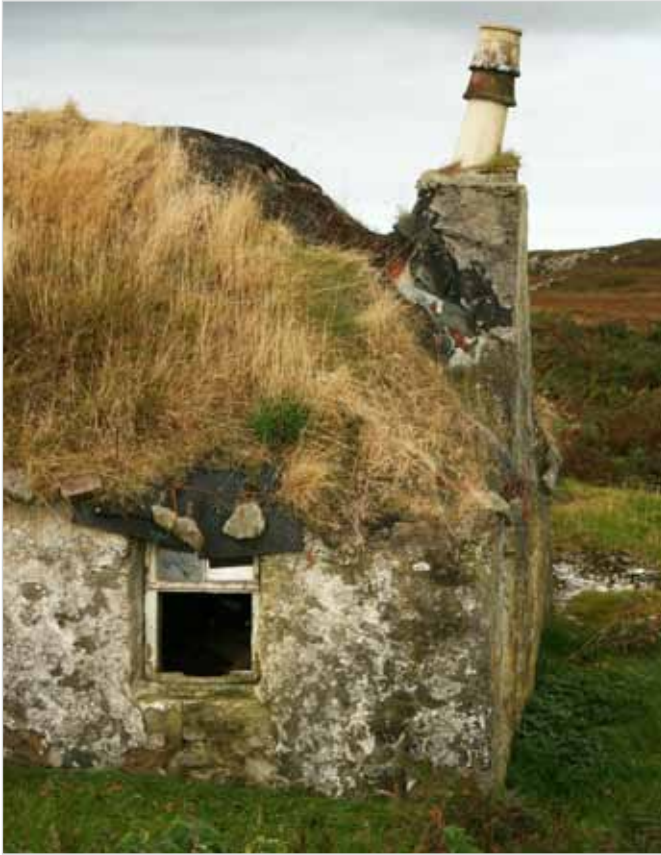
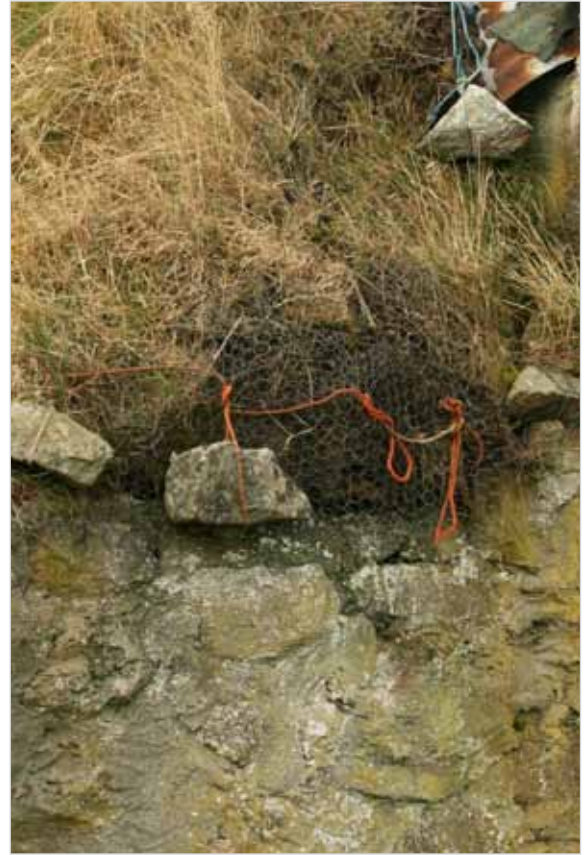
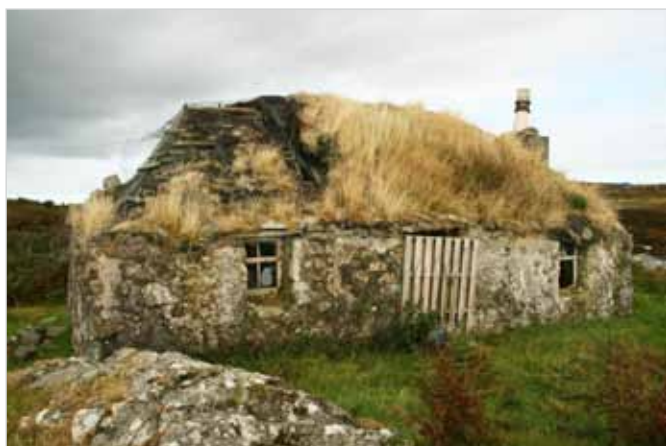
I Aird Cumhang – Western Isles

Additional Notes: ..... Late 19th/early 20th-century thatched cottage, listed as having a 'muran thatch roof, secured with ropes and stone weights'; however, the building is now vacant and is in a severe state of deterioration. The roof is in a particularly poor condition: large areas of thatch are missing, exposing the roof structure and building's interior beneath. The thatch appears to have been marram grass with a turf underlay, yet the little thatch that remains has heavily deteriorated and is overgrown with vegetation. The netting over the top of the thatch, and across the now partially thatched ridge, is still mostly intact, and the remains of weighting stones attached to

..... Poor

the netting by string are still visible in places along the wallhead and around the chimney stack at the north-east end. The building is abandoned and has been on the Buildings at Risk (BAR) Register since 1996 (BAR reference number 1681).

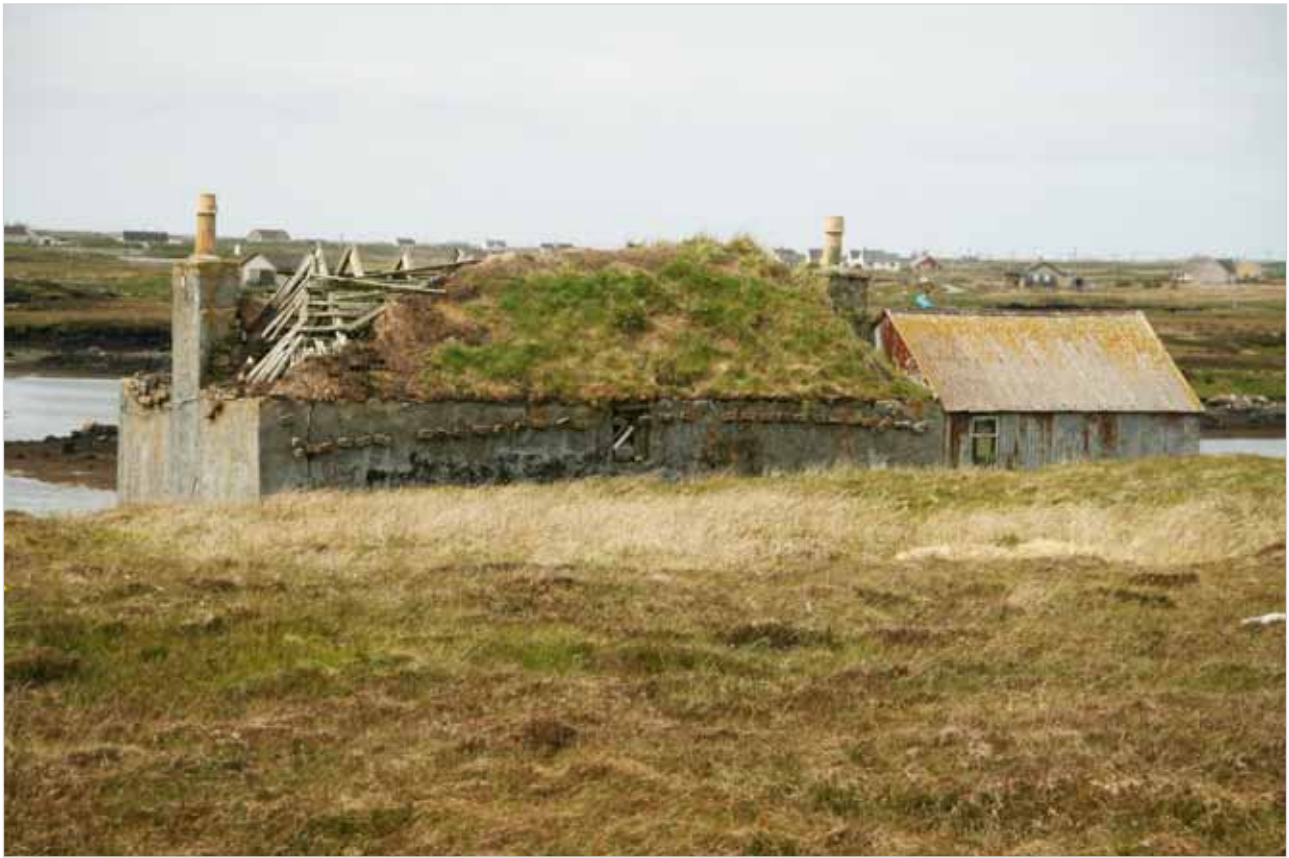
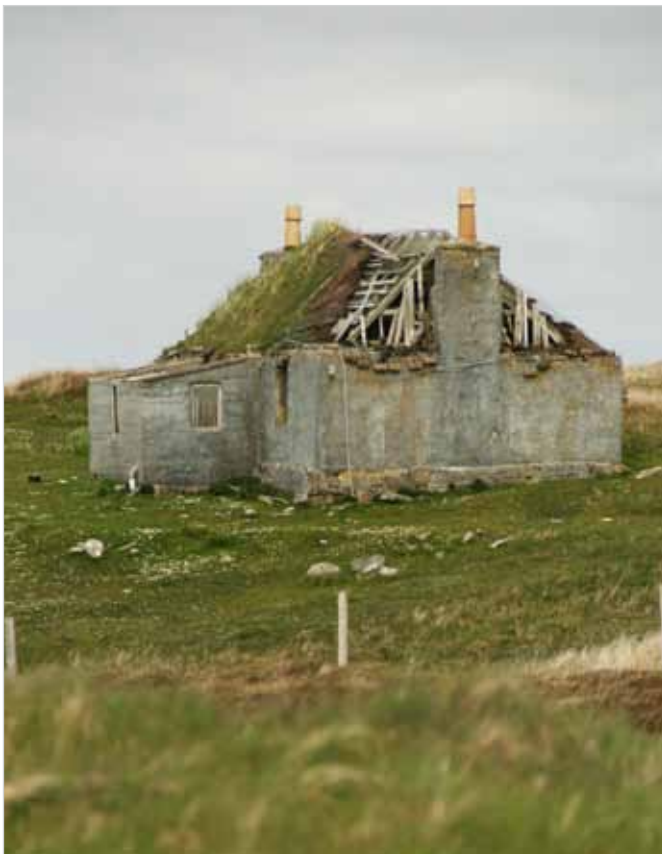
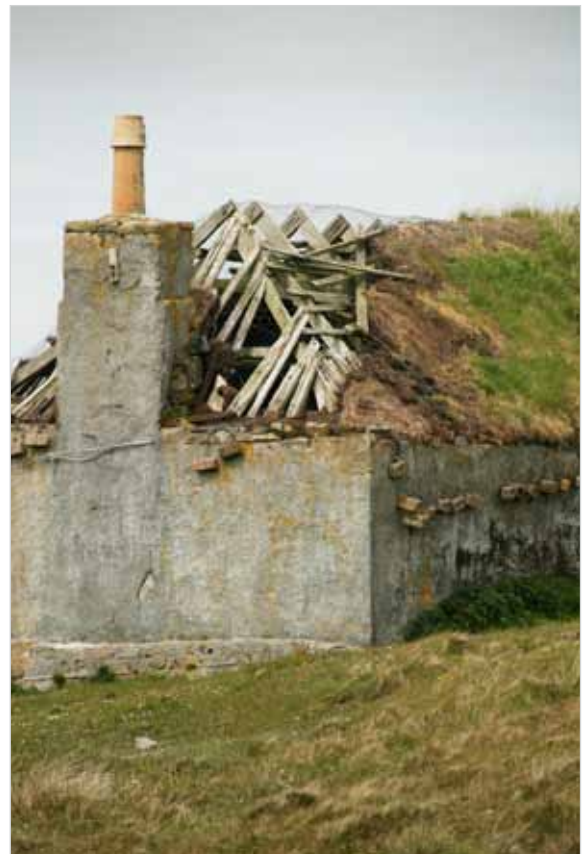
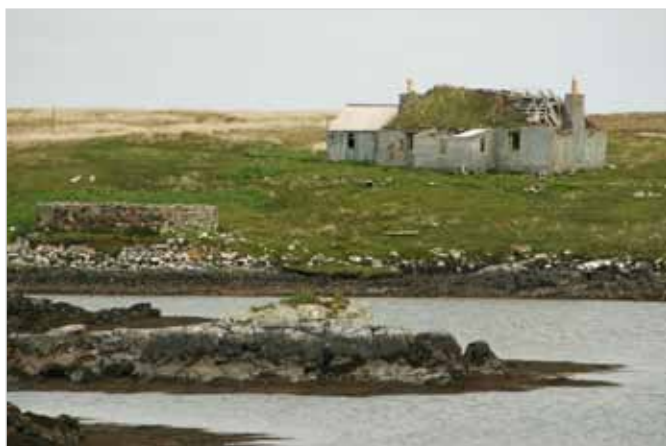
Rhughasinish Thatched Cottage – Western Isles

Condition of Thatch: ..... Poor

**Additional Notes:** ..... Single-storey cottage made from concrete with adjoining corrugated iron roof outbuilding to the north gable. The cottage, which appears to be thatched in marram with a continuous marram ridge, is in a derelict condition and much of the thatch is missing, exposing the interior of the building. The remaining thatch is heavily overgrown with grassy vegetation growth and there is visible evidence of netting, which is weighted down at the eaves with bricks secured to the netting with string. Many of the weighting bricks have fallen to the ground or are hanging much lower than they originally would have. The south end of the roof, which is in the poorest condition, appears to be close to collapse. ....

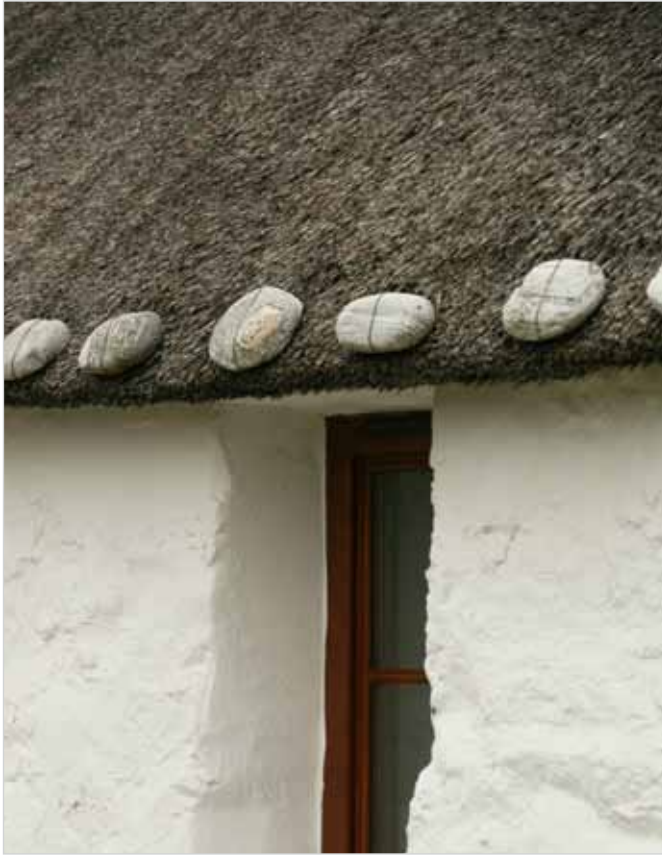
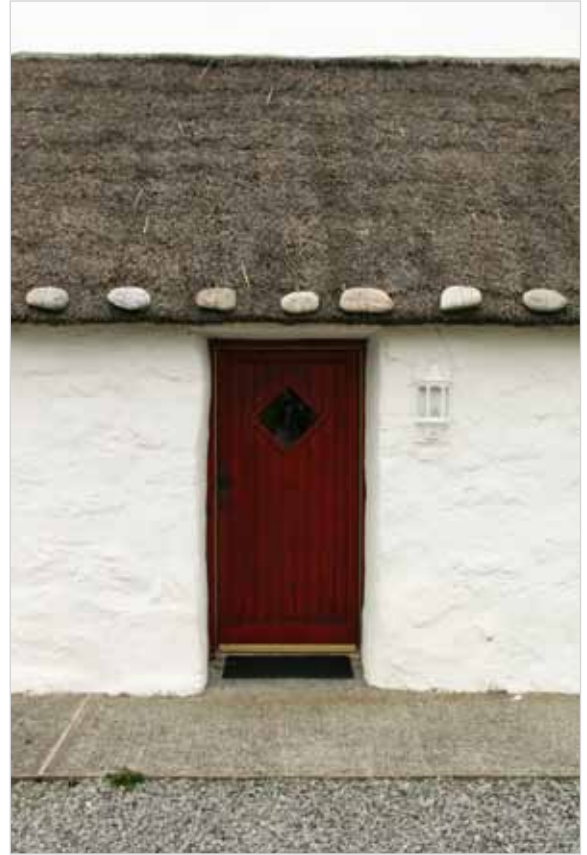
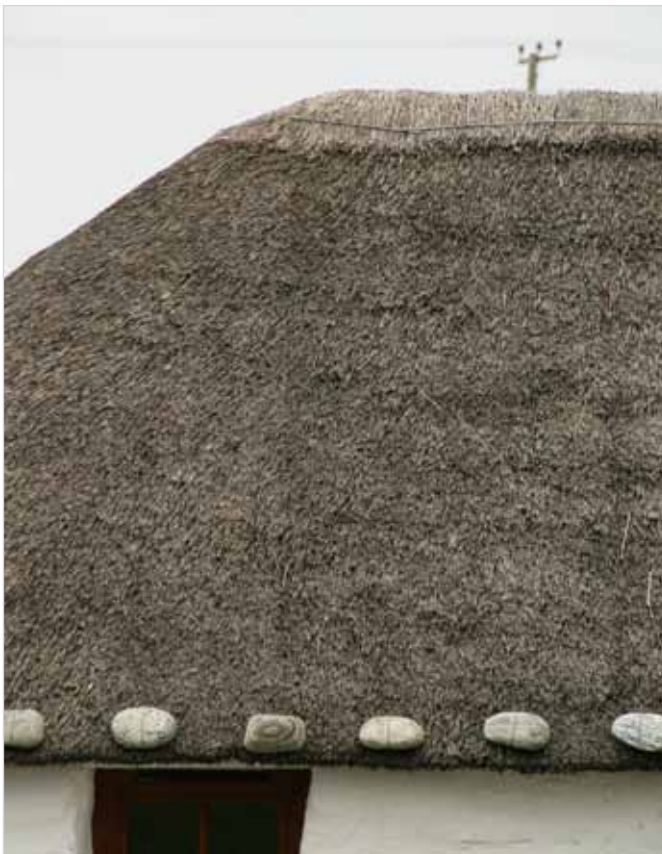
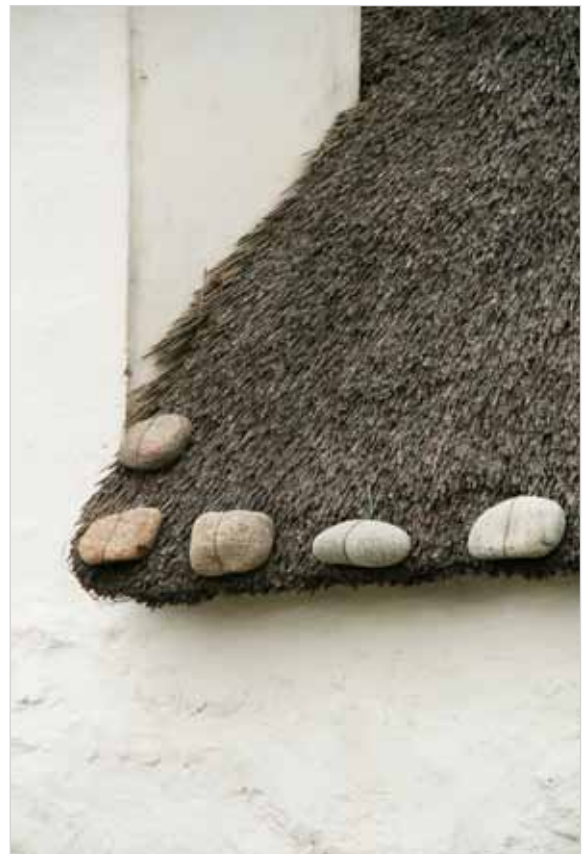
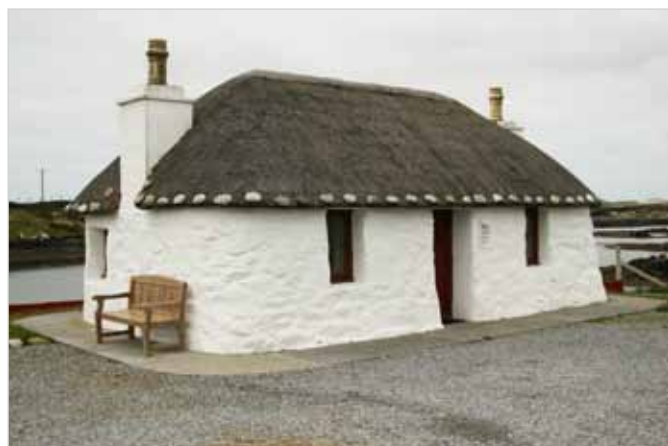
Ronald's Cottage – Western Isles

..... Good

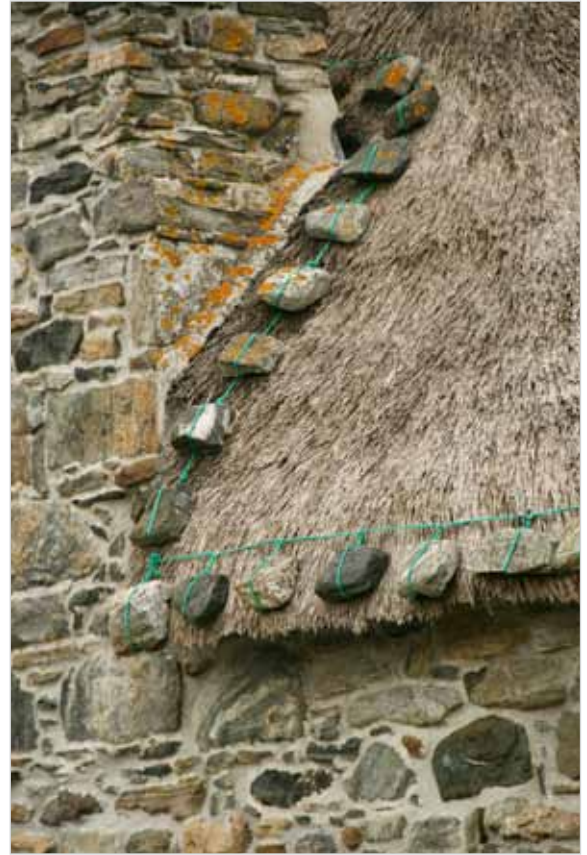
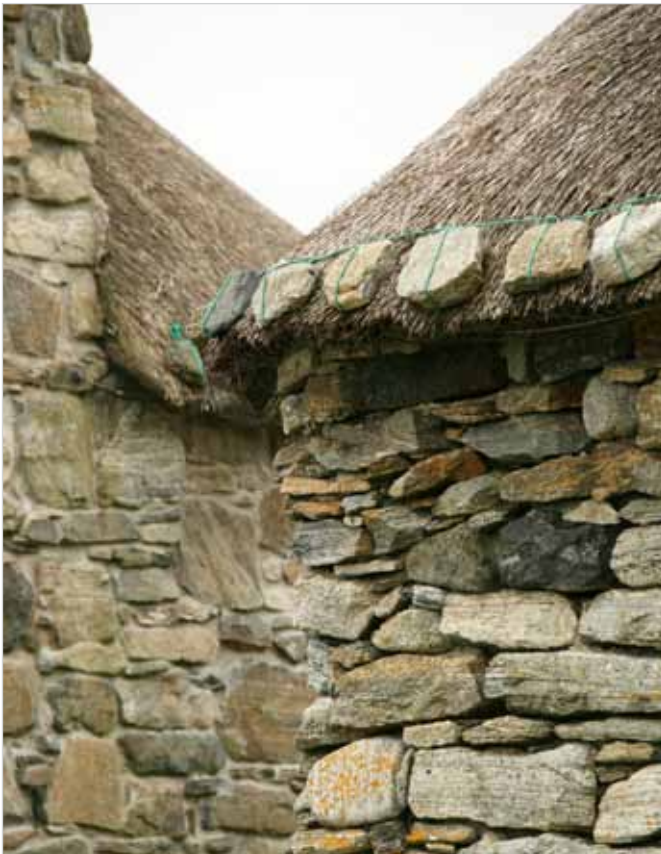
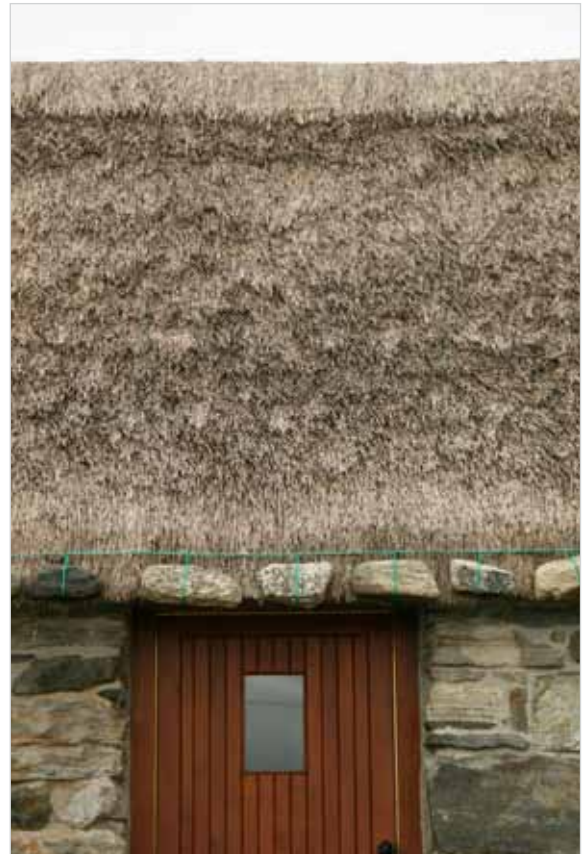
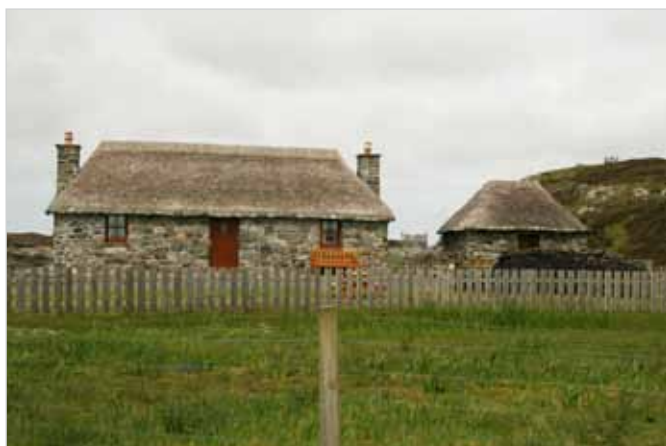
The Shielling by the Bay – Western Isles

..... Good

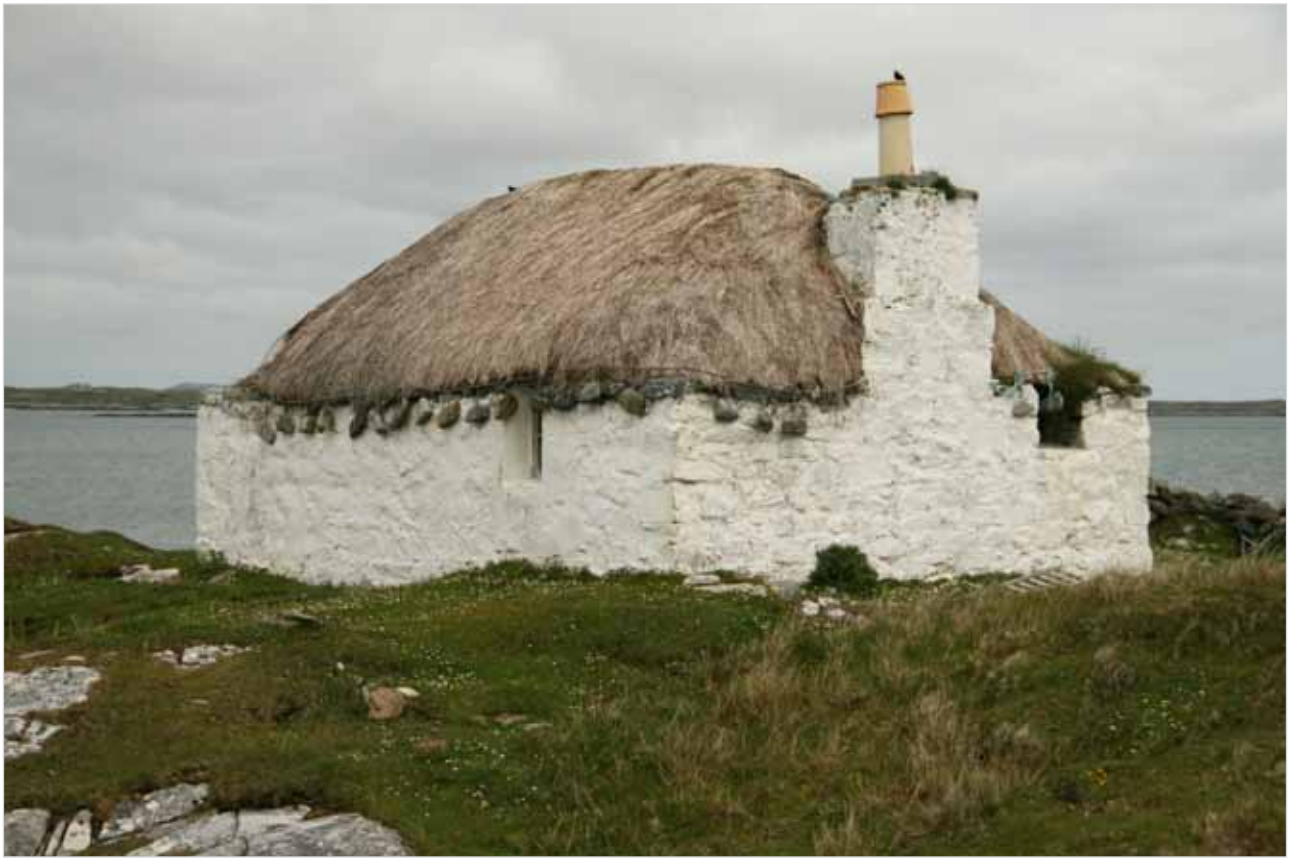
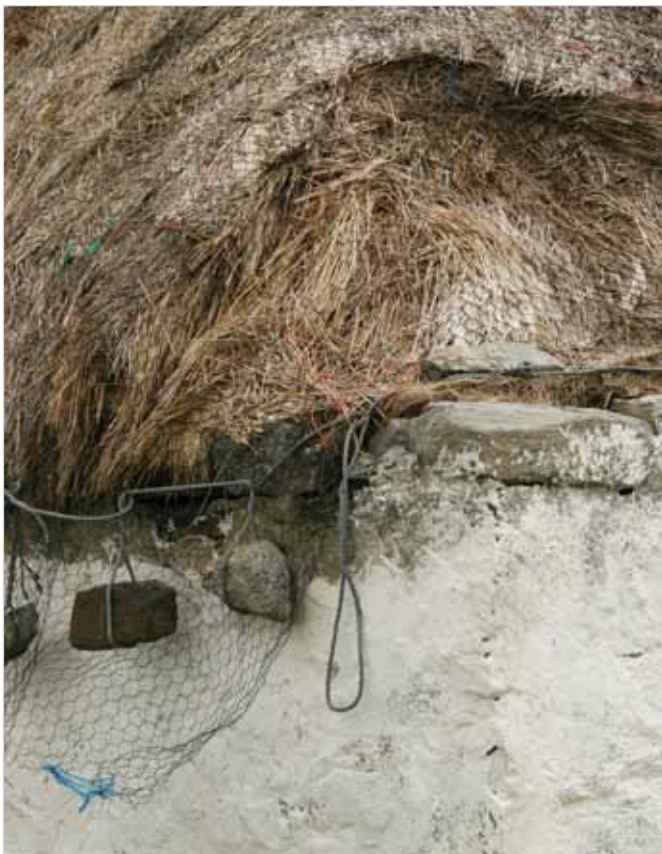
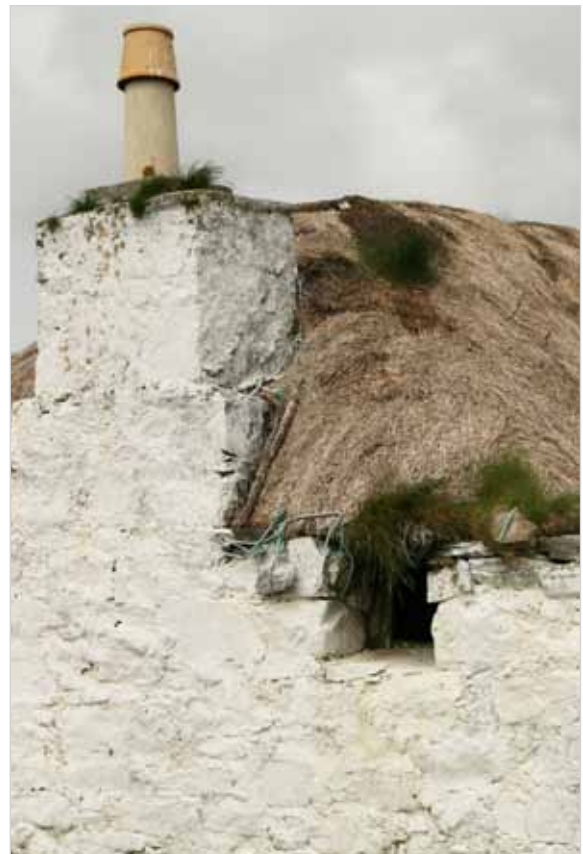
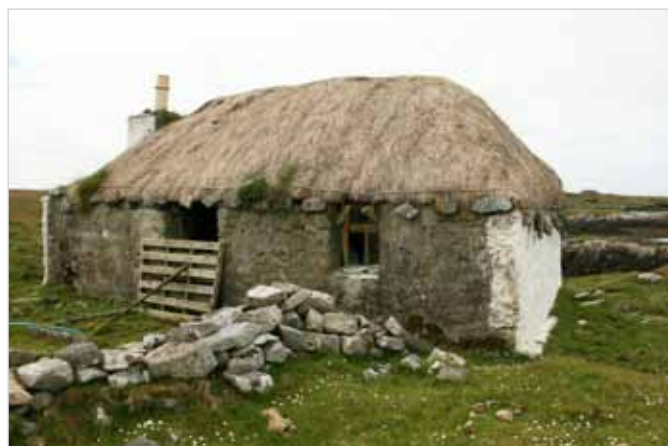
Address: ..... I I Rhughasinish

Condition of Thatch: ..... Poor

and has been entirely netted, including across the ridge. The netting has been weighted along the eaves by stones

that have been secured to the netting by a continuous piece of thin rope passed through the holes in the net. The

areas of thatch missing or dislodged across the

particularly on the east elevation. The owner plans

to re-thatch the roof within the next year.

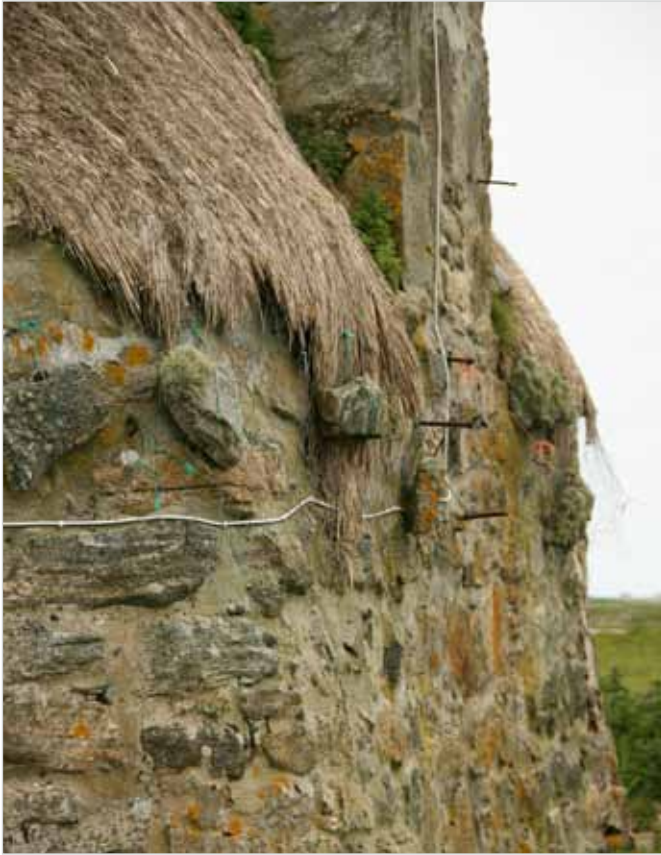
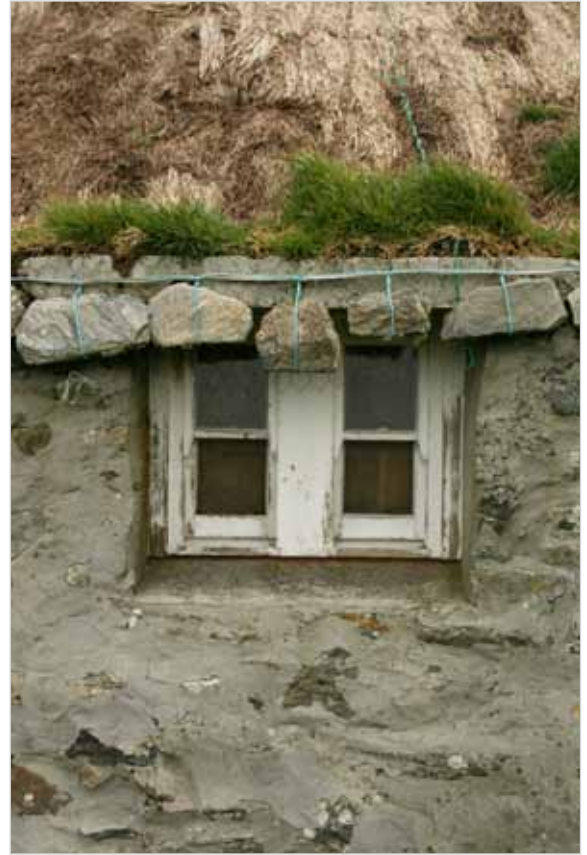
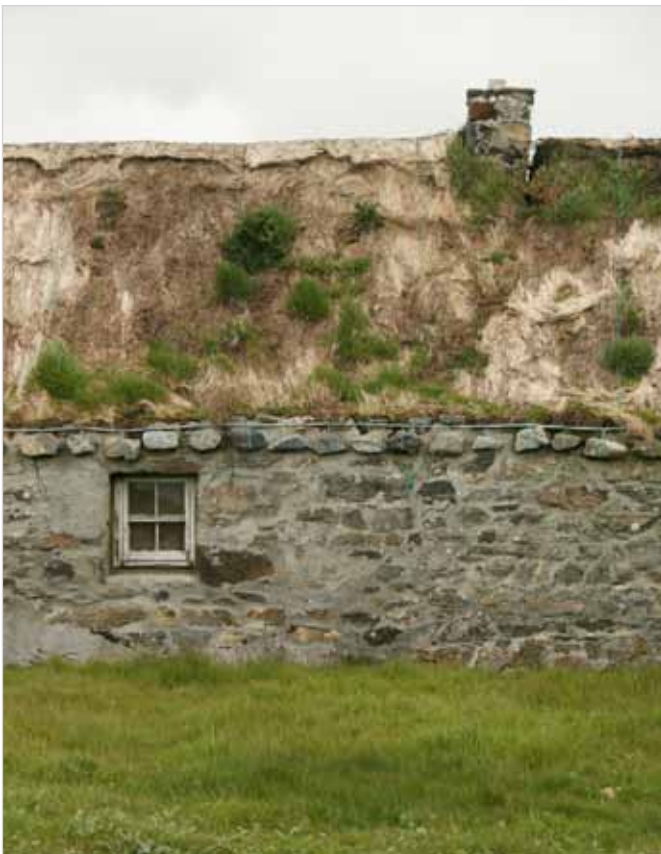
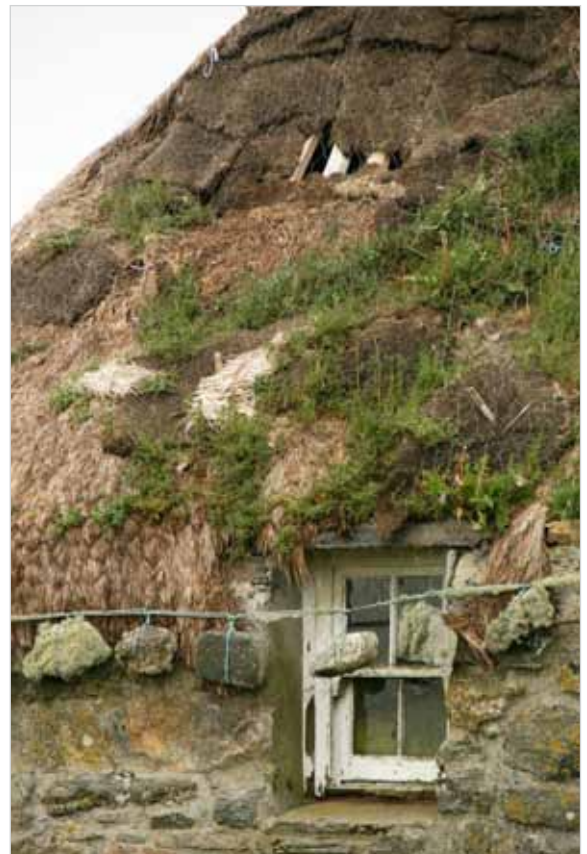
Address: ..... 99 Carnan

Condition of Thatch: ..... Poor

..... The building retains a marram-thatched roof with a marram ridge; however the building is vacant and the roof is in a poor condition. There are some areas where the thatch is missing, exposing the interior of the building and the layer of turf underneath the marram, as well as having a significant opening around the chimney stack along the ridge. The surface of the thatch is also heavily overgrown with grassy vegetation. The roof has been entirely netted,

..... including across the ridge, which is weighted along the eaves by stones secured to the netting by a continuous string passed through the holes in the net. The stones and netting remain intact; however, some of the stones appear to be sagging and loose in places. The cottage has a modern porch extension to the east with a corrugated iron roof.

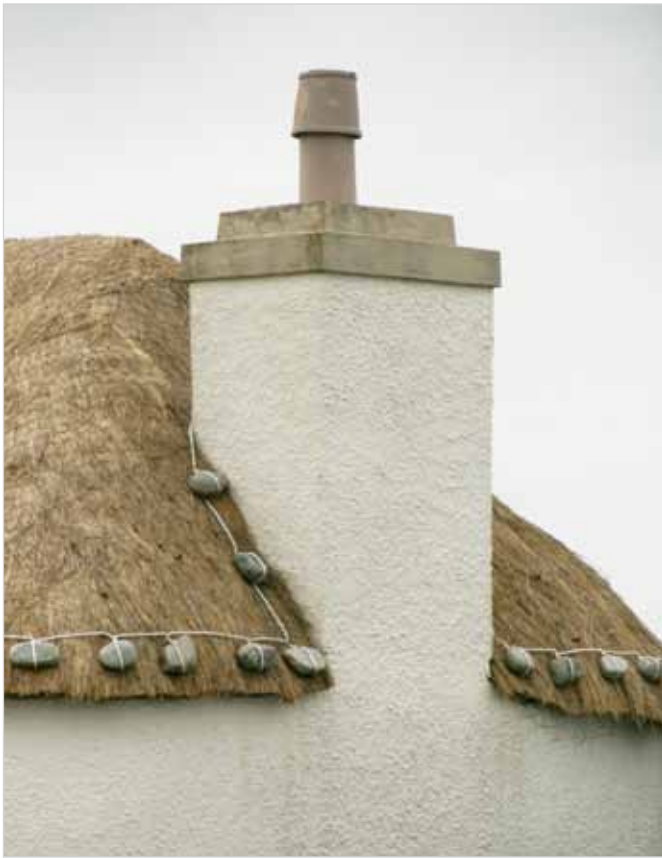
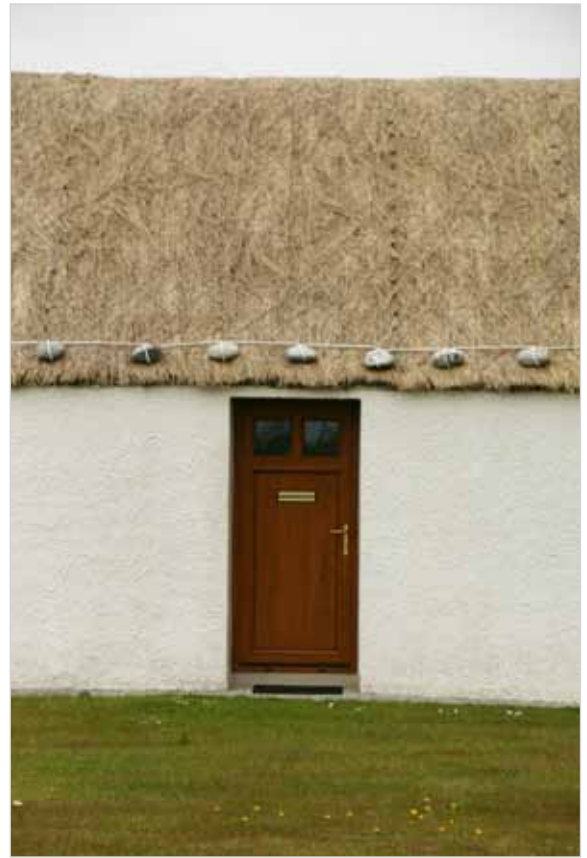
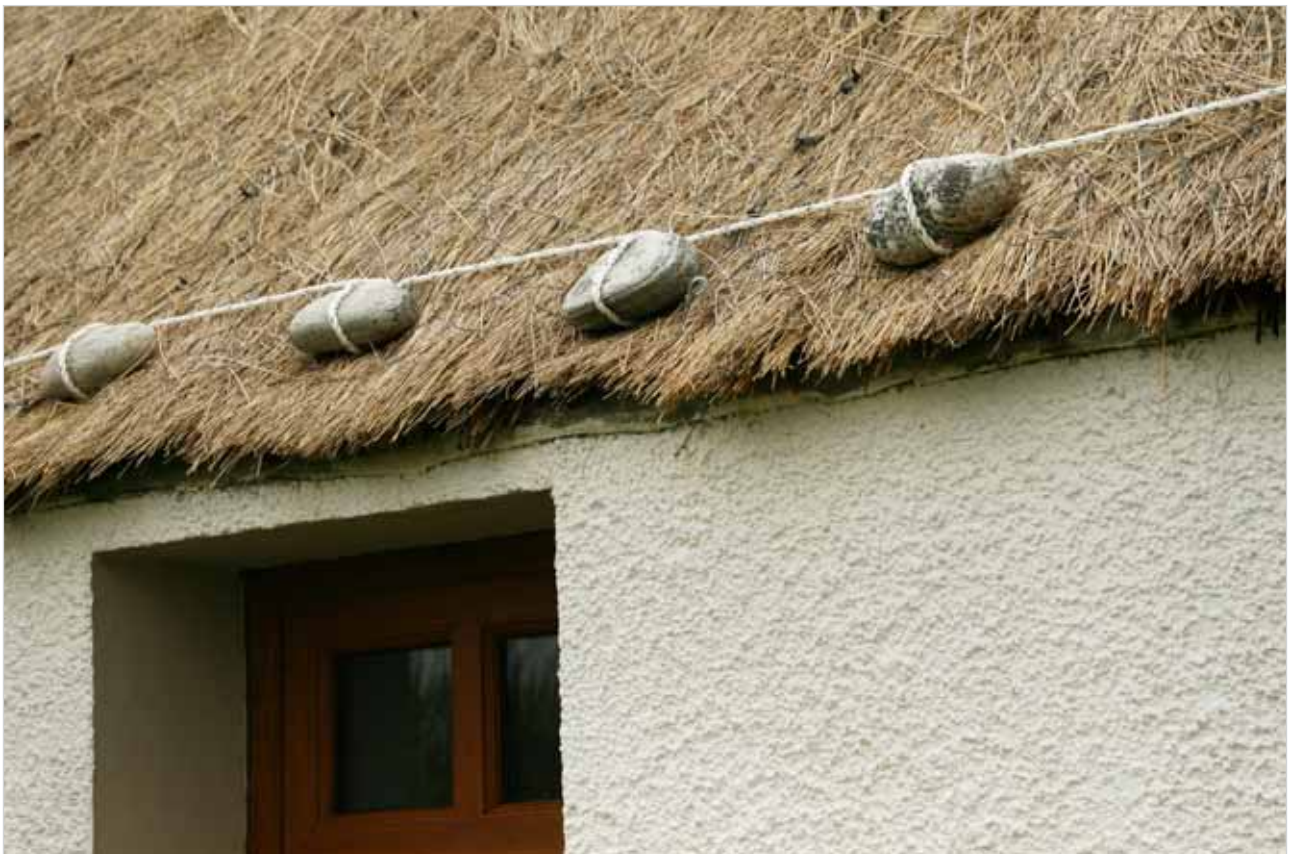
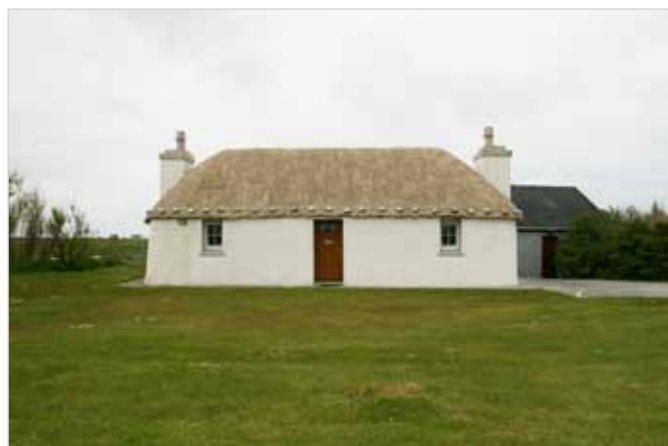
Bualadubh Thatched Cottage – Western Isles

Condition of Thatch: ..... Good

Additional Notes: ..... Cottage of unknown date, currently has a marram-thatched roof with continuous marram ridge. The roof is entirely netted, including across the ridge, which is weighted just above the eaves and around the chimney stacks at either end with stones secured to the netting along a continuous string of thin rope passed through the holes of the net.
